THE BOATYARD

Prevent Mainsheet Fouling At The Split In The Fairlead Ring.

By Chuck Winder

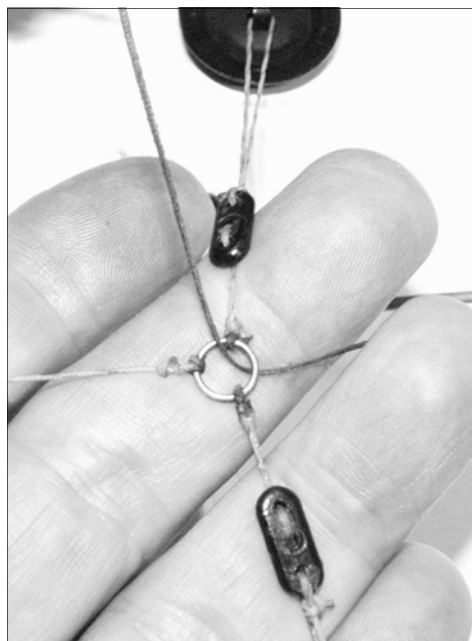
To avoid this is simple. Three strings control the ring location. Tie the forward string to the ring so it covers the sharp ends of wire in the ring. Take a few turns of string so no wire ends are exposed. Saturate the turns with CA glue to further cover the wire ends. See photo.

Mainsheet Fairlead Ring

The sharp wire ends of the stock fairlead ring for the mainsheet are often a problem:

1. They can wear the mainsheet to the point where it fails,
2. They snag the sheet on the sharp wire ends of the ring, preventing sail trim.
