## BOAT MAINTENANCE

### Jib Boom Tack Fitting Failures

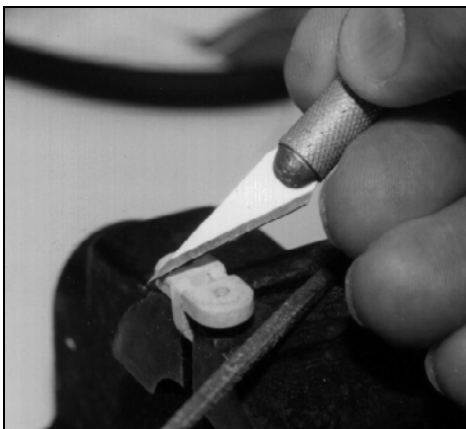
Groove the eyelet to recess the line

Use an Exacto knife and/or a small file to put shallow grooves in the bottom and sides of the base. (Photo below left.) This allows the base to sit flat on the hull and provides clearance at the sides so the eyelet will fit into the deck recess. A shallow groove at the top of the eyelet may help keep the line wrap in place. Then wrap the eyelet as shown with three

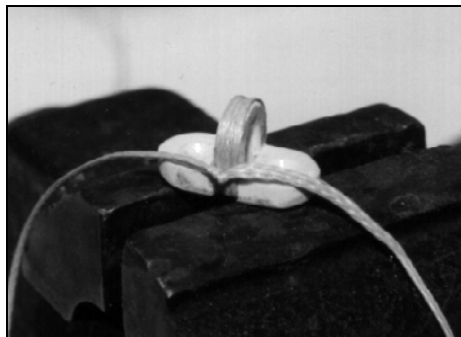
Reinforce the eye with wraps of line

turns of rigging line. If you have it, use Kevlar line. Get as much tension in the wrapped line as you can manage. Secure the line with CA or epoxy glue.

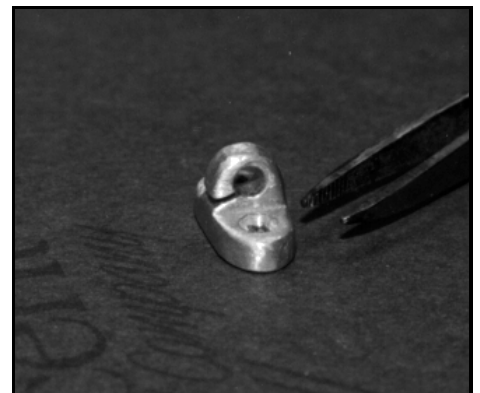
Aluminum Eyelet

The photo on the right shows an aluminum eyelet. It was shaped from a piece of aluminum to have the same shape and size as the plastic eyelet. A hack saw, files and sand paper shaped the part. The holes were drilled. Aluminum is soft an easy to work. Brass would be suitable, too.

Since aluminum is so much stronger than the plastic eyelet, a slot was made in the left leg of the eye. The jib boom tack line can be removed from the eye without cutting the line. This allows easier removal of the rig from the hull.
